Contract #: 04-0120F4Cty: SF/ALA Rte: 80 PM: 13.2/13.9File #: 69.28**WELDING INSPECTION REPORT****Resident Engineer:**Siegenthaler, Peter**Address:** 333 Burma Road**City:** Oakland, CA 94607**Report No:** WIR-025663**Date Inspected:** 09-Jul-2011**Project Name:** SAS Superstructure**OSM Arrival Time:** 1900**Prime Contractor:** American Bridge/Fluor Enterprises, a JV**OSM Departure Time:** 700**Contractor:** Zhenhua Port Machinery Company, Ltd (ZPMC), Changxing Island **Location:** Shanghai, China

## WELDING INSPECTION REPORT

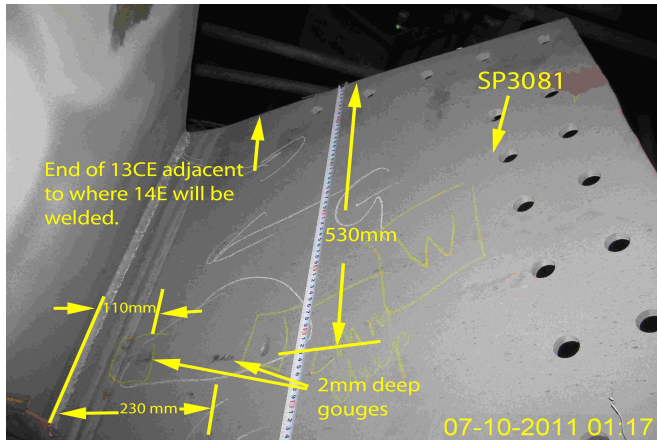
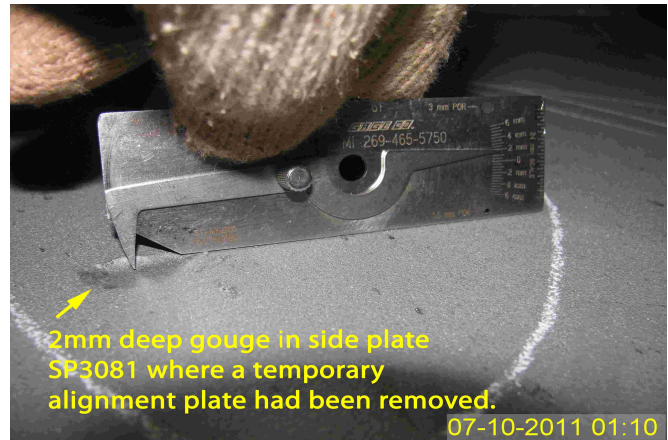
ZPMC requested Caltrans personnel to perform visual inspections of OBG segment 13W cross beam side interior surface upper edges of side plates SP3079, SP3080 and SP3081 between panel points PP121 and PP124.3 following the initial pre-blast cleaning of the steel surfaces. This QA Inspector along with three other QA

Inspectors performed random visual inspections of these areas and observed multiple areas that require grinding to remove arc strikes, sharp edges, minor gouges, temporary welds and two areas that require weld repairs. The locations where weld repairs are needed appear to be where ZPMC gouged the base material to a depth of approximately 2mm when they removed temporary alignment plates. This QA Inspector issued a “Blast Incident Report” to document the locations of these weld repairs. See the photographs below for additional information.
